# Case Study

## Integrated Offshore Pipeline Abandonment and Re-direction Solution

Intero supported Dana Petroleum Offshore with the abandonment, re-direction, testing, and dewatering of the P11-B Unity pipeline. The project involved safely disconnecting the existing pipeline from P12-SW and re-routing it to the P15-D platform, followed by full integrity verification of the new pipeline system.

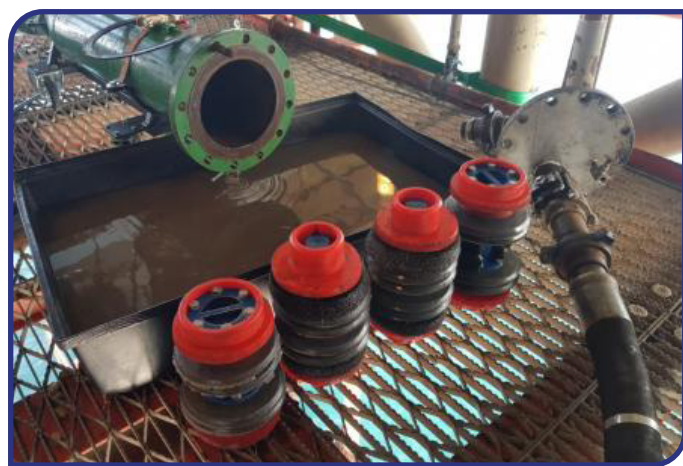
To overcome these challenges, Intero Integrity engineered and delivered a tailored offshore solution. Lightweight temporary spool pieces and a compact pig trap were designed and fabricated in-house, allowing safe installation without crane support.

A dedicated water treatment and filtration system was deployed on P12-SW, enabling controlled discharge of flushing water while maintaining hydrocarbon levels below regulatory limits. Cleaning operations were executed using a carefully designed pig train, ensuring effective internal cleaning prior to flooding and abandonment.

Following re-direction to the P15-D platform, Intero performed a full pipeline leak test at 103 bar(g) with a 24-hour hold period, witnessed by the client and Bureau Veritas. After successful testing, the pipeline was dewatered using a multi-diameter BiDi pig propelled by production gas.
