# Case Study

## Heater Inspection for Complex Tube Configurations

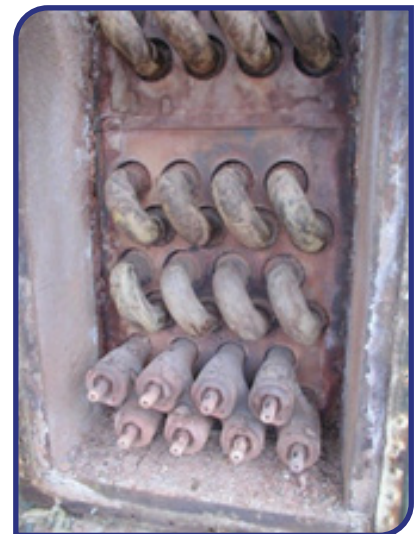
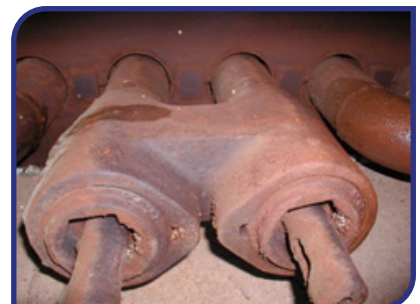
For example, prior to carrying out this inspection at our client's refinery, Intero built a test loop at our research and development facility in Tricht, The Netherlands. Our customer was not able to provide the original plug header, so we designed a replica version with identical internal dimensions. We then performed test inspections to prove passage through the plug header bend with the modified Intero inspection tool.

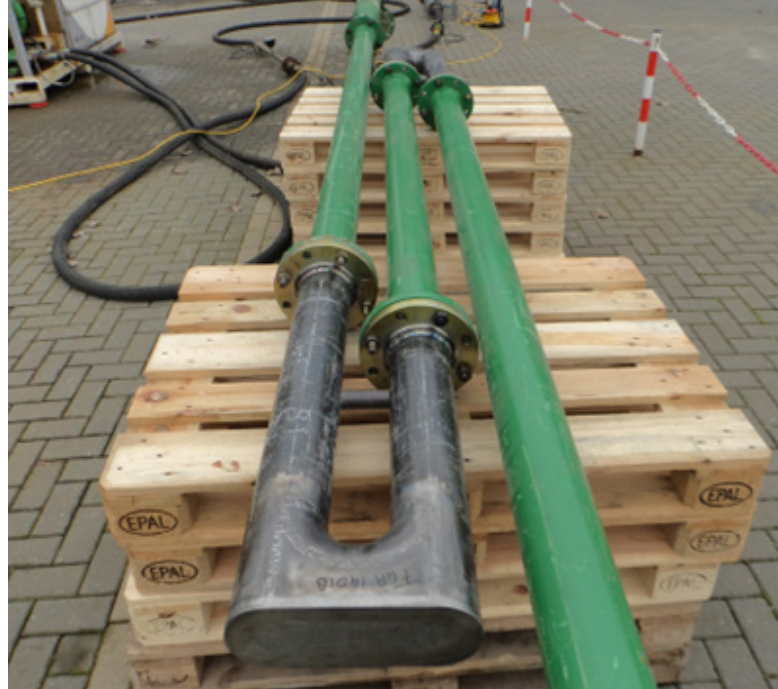
During the "live" inspection of the heater at the client's premises, Intero executed the test scans in less than an hour per pass, with no problems. Our client was extremely pleased, as other contractors failed on multiple previous attempts.

- Inspection executed with success
- Inspection results reported in color detailed corrosion profile maps
- Local thinning detected in tubes
