Case Study

Intelligent Pigging of 13.5 km Multi-diameter Pipeline (4", 6", 8" Pipeline)

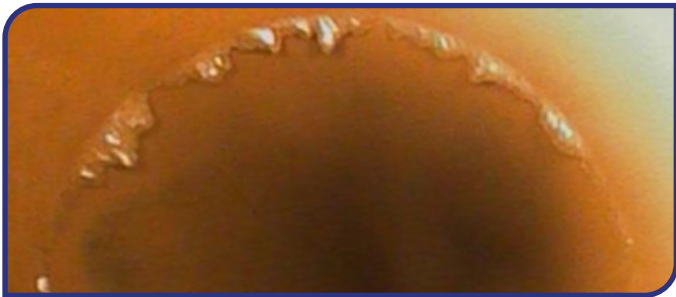
- Multiple heavy wall bends, which included an internal diameter of 132 mm
- 13.2 mm weld-penetrations in the 6" pipe sections

The internal obstructions combined with the multi-diameter complexity required a detailed engineering review to create a tailor made, flexible ILI solution to achieve the best possible results.

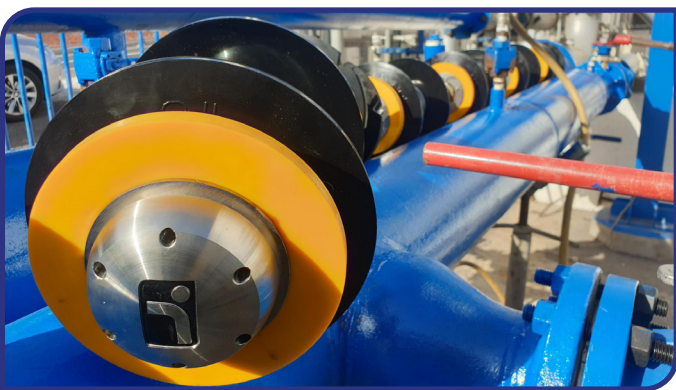
Next, Intero engineered its standard unpiggable ILI tool to overcome the multiple complex challenges of the pipeline.

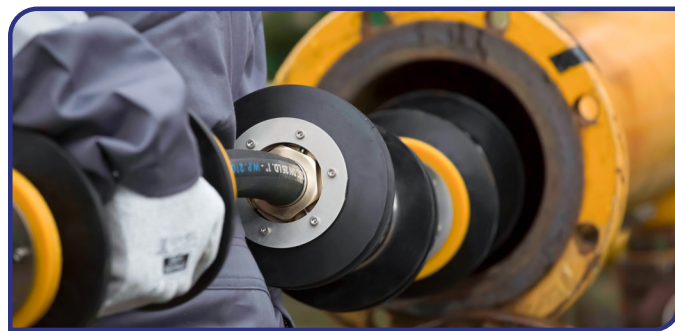
Because of the complexity of this pipeline's configurations, Intero ran a dummy tool prior to the ILI tool. After the successful dummy run, Intero launched the inspection tool. Through the 8"-6"-8"-6" sections of the pipeline, the Intero field team noticed pressure variations on the gauges at the launcher.

The significant weld penetrations in the older pipeline sections also provided data quality challenges. Intero and the client decided to improve the inspection results by recording a second data set on the last 5.5 km of the pipeline. Since Intero designed its tool to inspect bi-directionally, as soon as the ILI tool entered the receiver, Intero immediately reversed flow and launched the ILI tool in the opposite direction (from receiver to launcher). The ILI tool successfully recorded additional high-quality data for the last 5.5 km of the pipeline.
